XX NKF Congress
21–23 October 2015
Helsinki, Finland

MONUMENTAL TREASURES

Preservation and Conservation

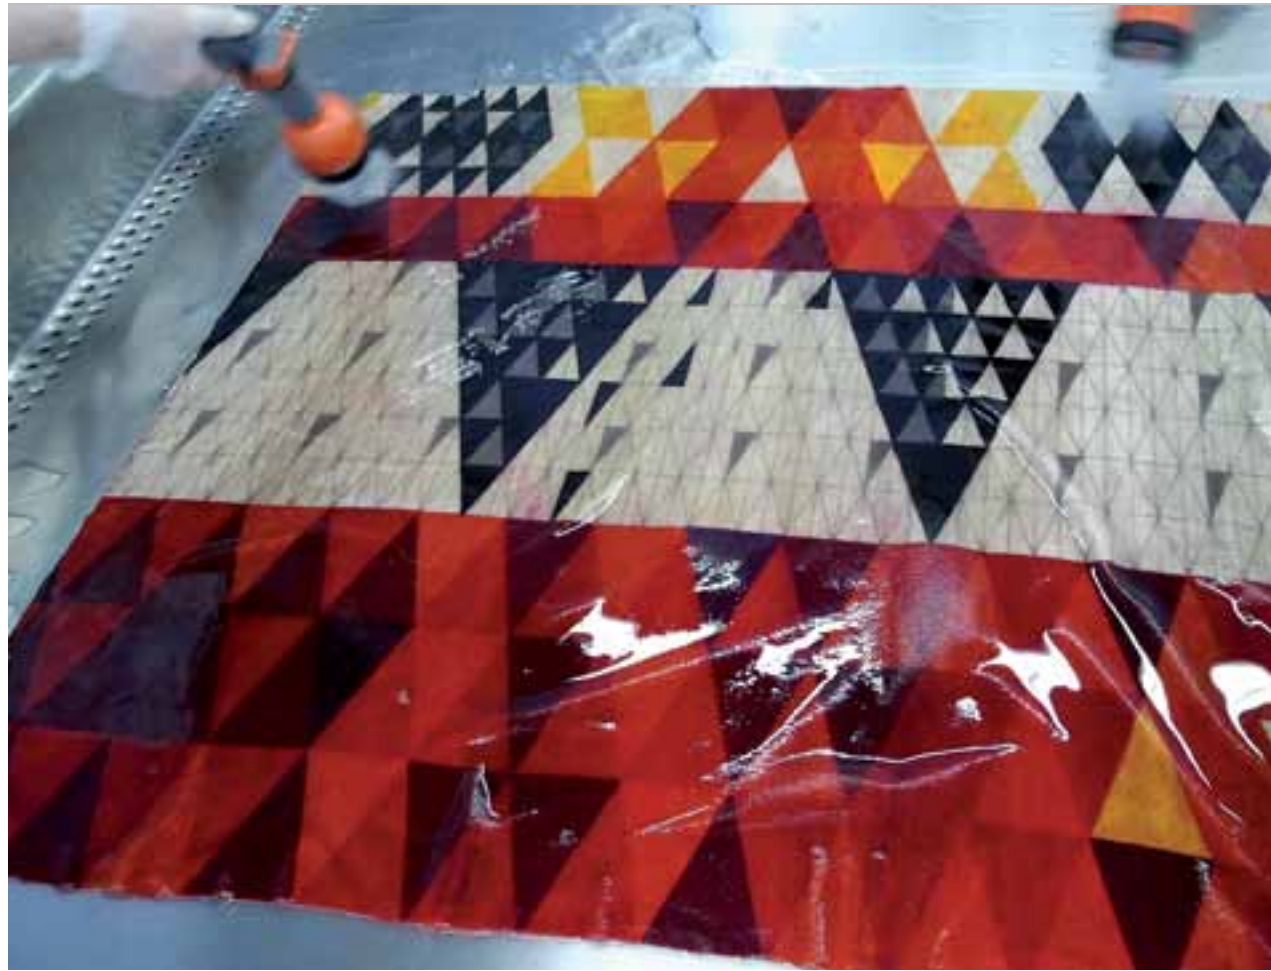
5. Dye leaking from the naturally-aged Pythagoras printed velvet. Photo: Judith Bannerman

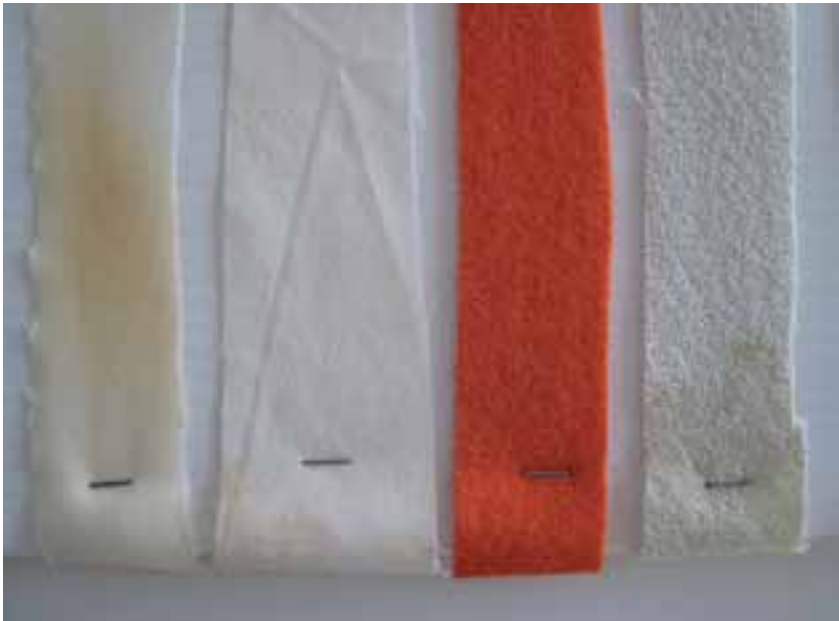
7. Samples exposed to natural light. Effects of Secura on test weave (to the left), orange and sand-coloured fabrics. Salt migration in the lower parts of the test weave and sand-coloured fabric. To the far left, brown discolouration on test weave treated with Apyrum. Photo: Margareta Bergstrand.

It was observed that in some cases, dark spots formed around the staples on samples that were mounted with metal staples. In one case, the sample treated with Secura, the staple corroded after a very short time. Ammonium salts, especially ammonium chloride, corrodes metals. This discolours textiles, but may also be a threat to curtains that are often mounted with metal devices.

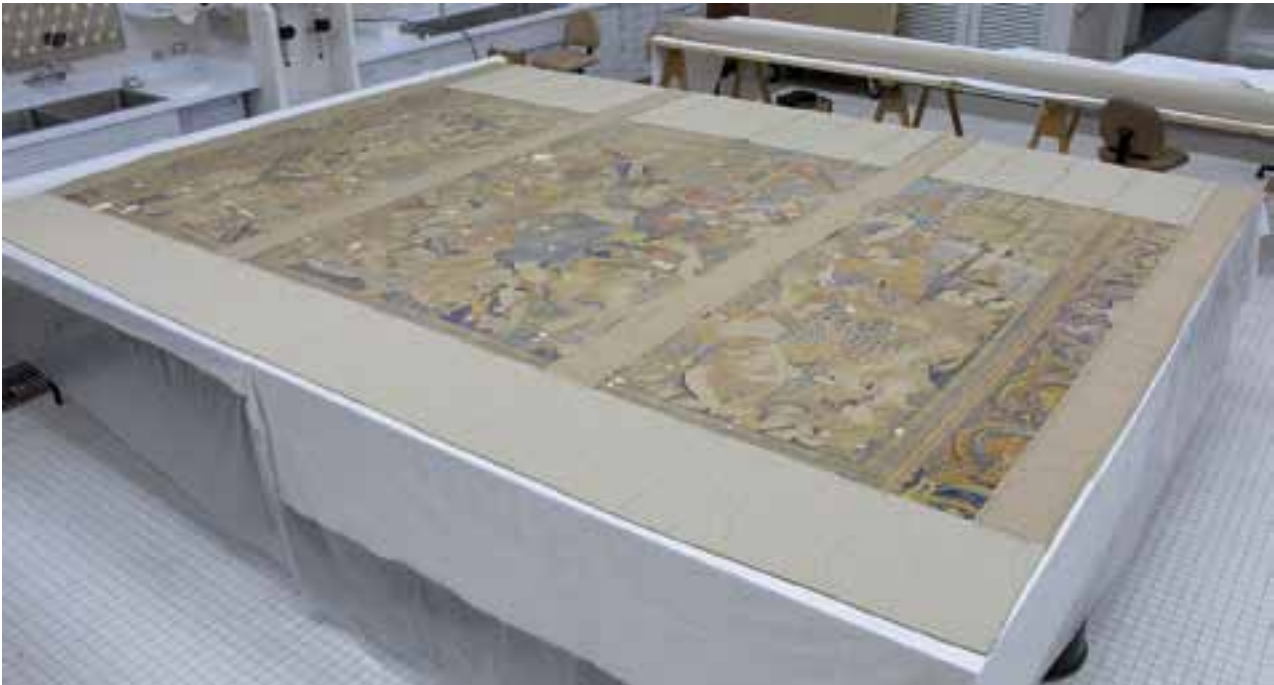
8. The reverse of the embroidery panel during the attachment of the backing support, while patches of various dimensions from previous restoration treatments were held in place. Photo: Giulia Chiostrini.

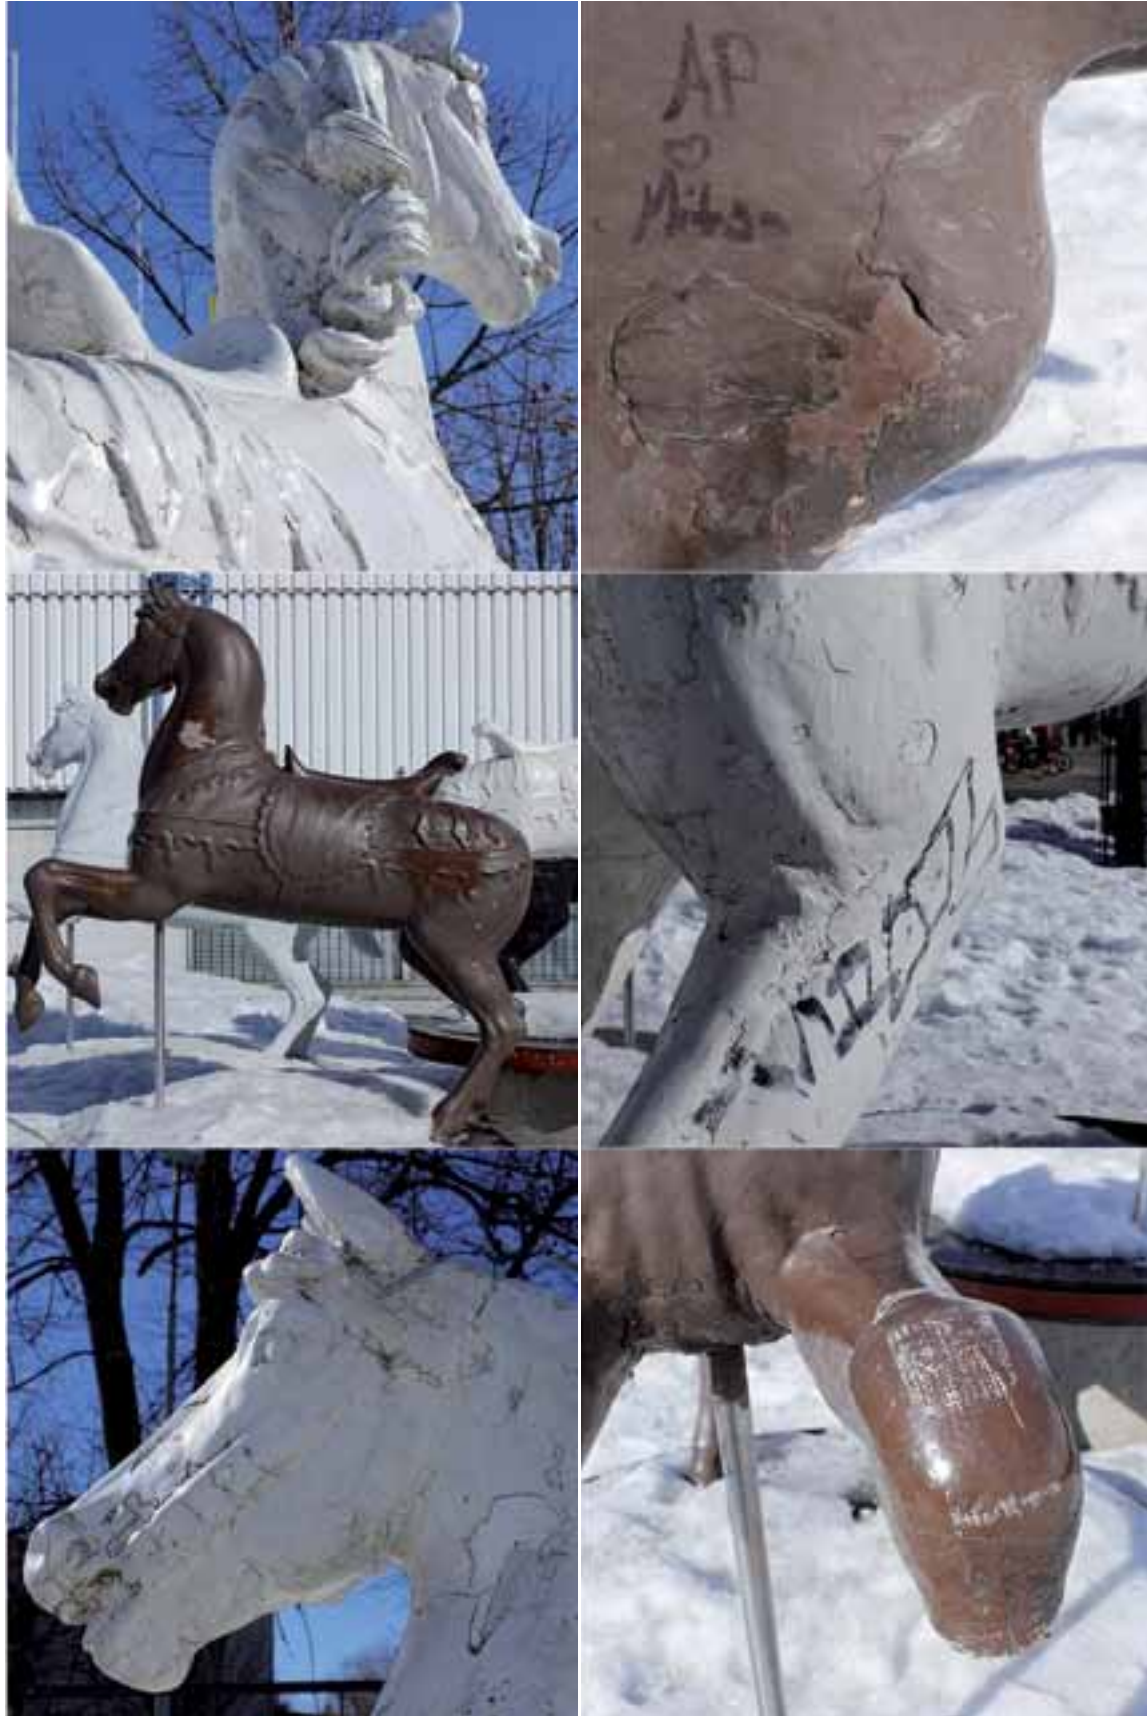
3. Thirty years in a public space leaves traces of encounters with people and outdoors. The Circus Monuments condition was very poor in winter 2013. Photo: Kerava Art Museum / Sirkushevoset sairastaa.

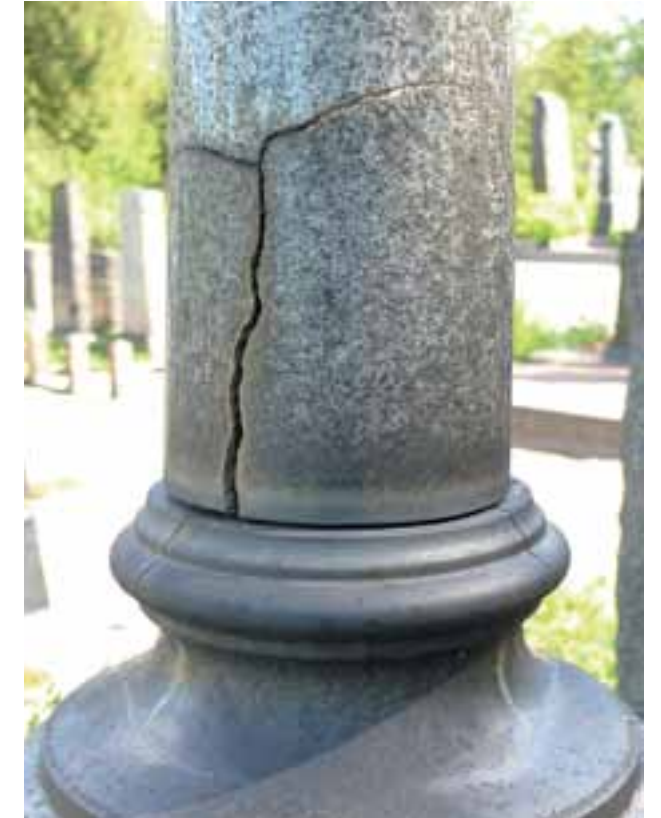
6. Many cracks on a marble grave monument due to freeze-thaw and corrosion of the dowel.

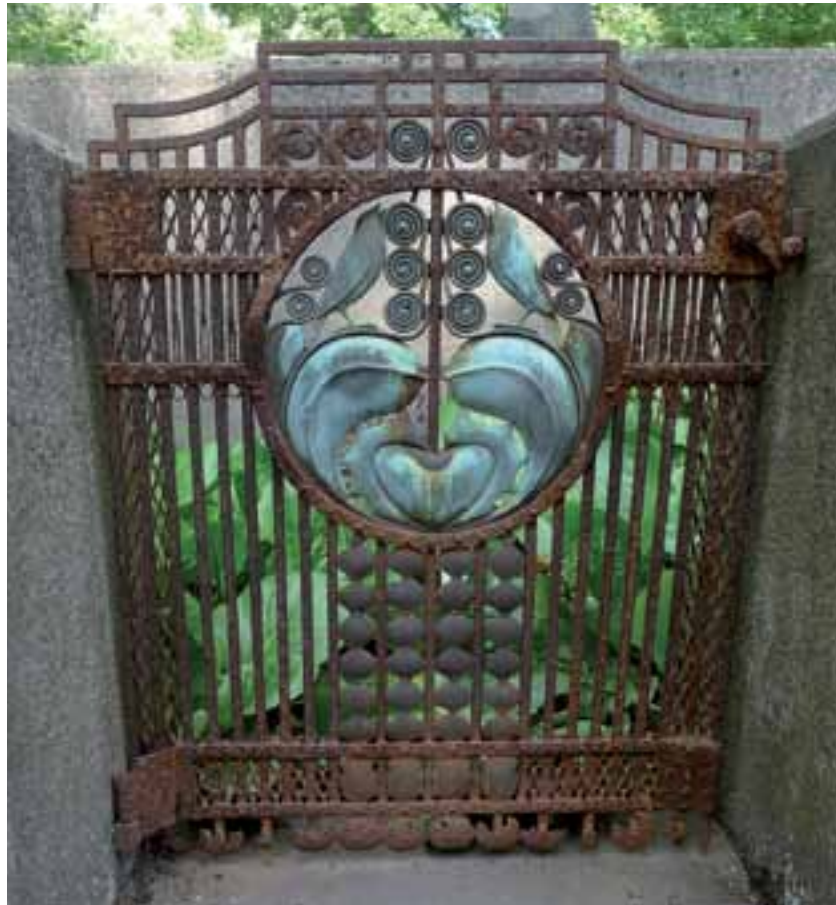
17. Ornate art nouveau gate at advanced stage of rusting, showing handicraft and mixture of materials.

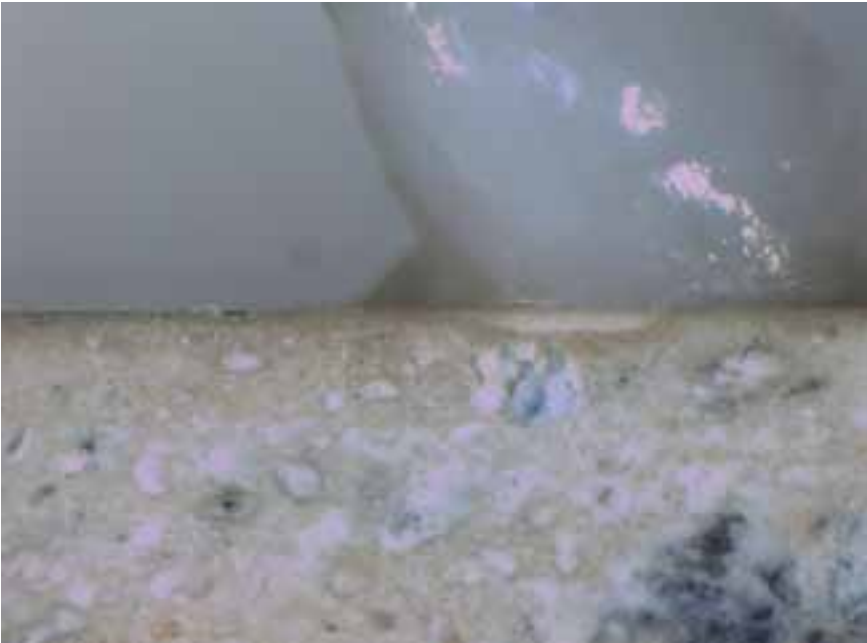
4. Cross-section of the North Hall scagliola with soap emulsion on top. Polished surface makes the top layer of gypsum glassy and turpentine or soap doesn't impregnate to the structure. (40X).

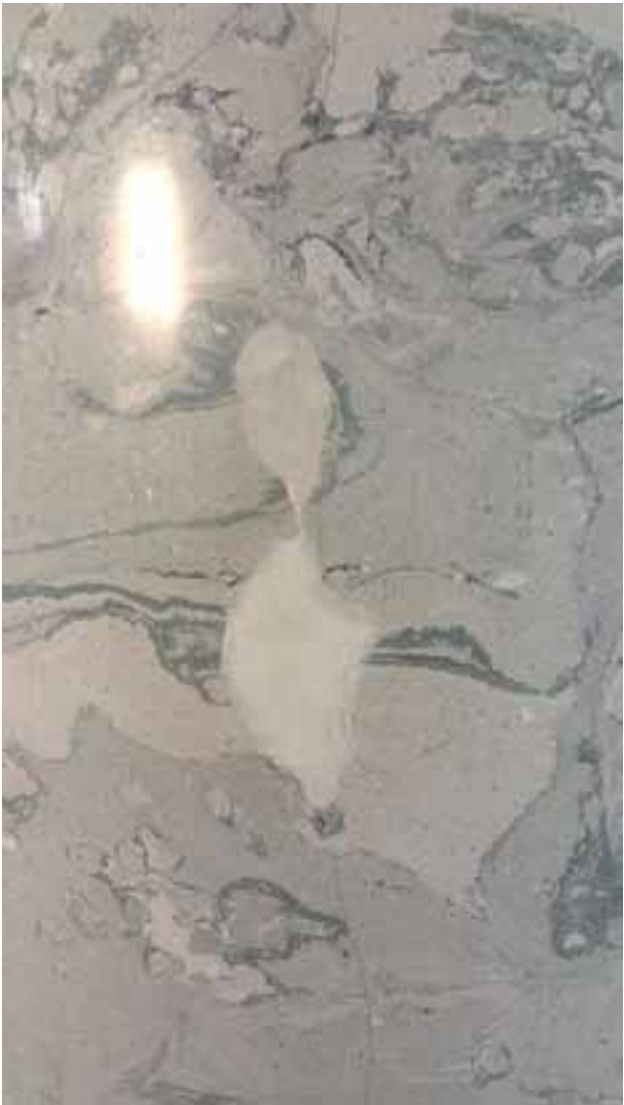
5. Missing area before patching.

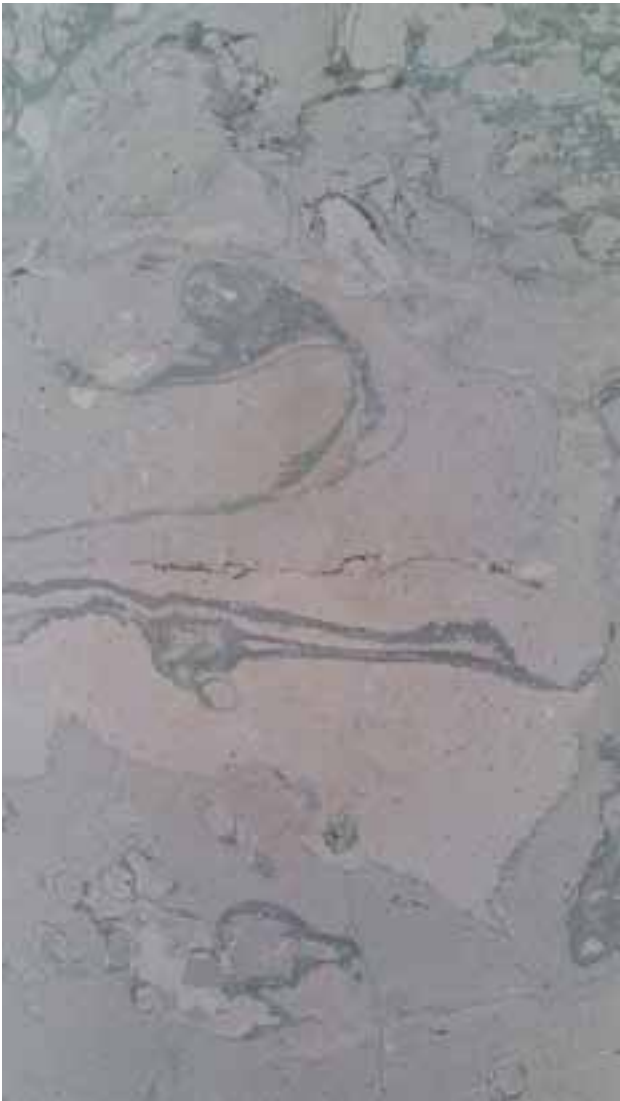
6. Missing area after patching with Modostuc and watercolours.

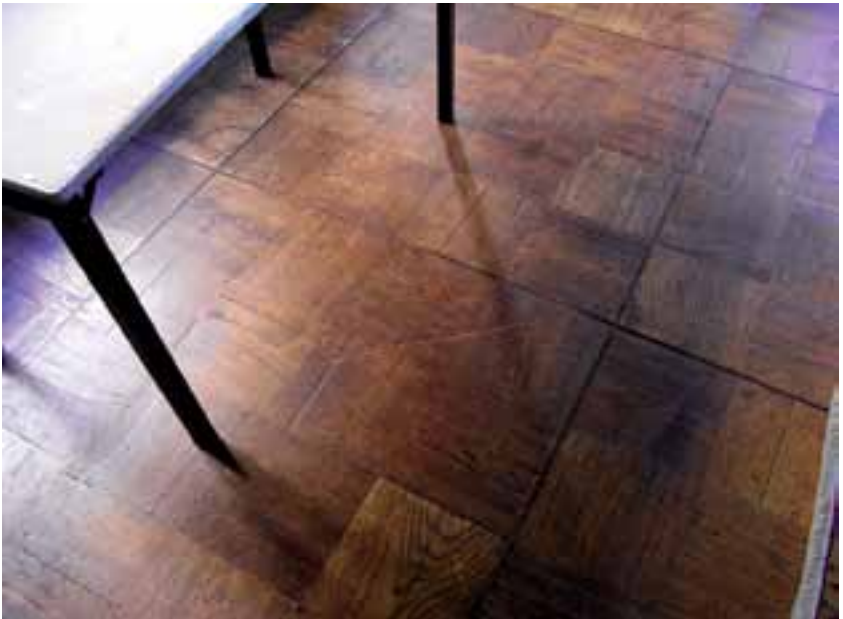
5. Signs of wear and tear from dragging furniture were sometimes testimony of incorrect use. Photo: Lisa Nilsen.

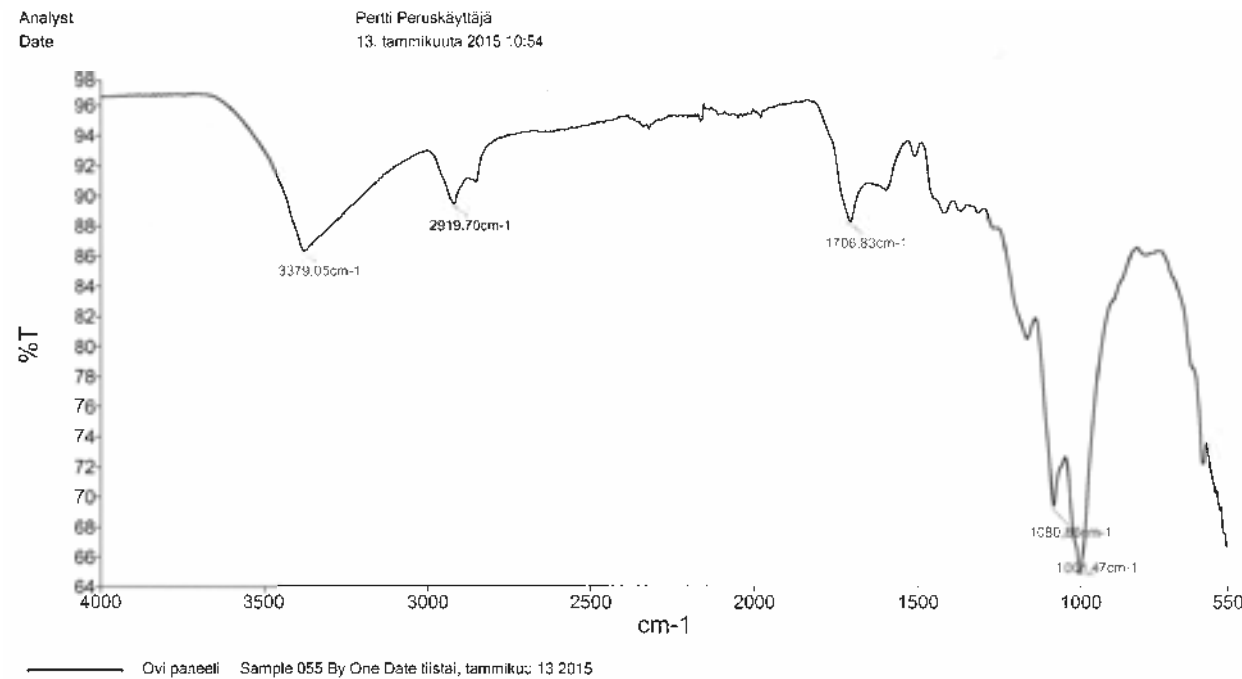
7. FTIR spectrum of the paint sample from the door panel.

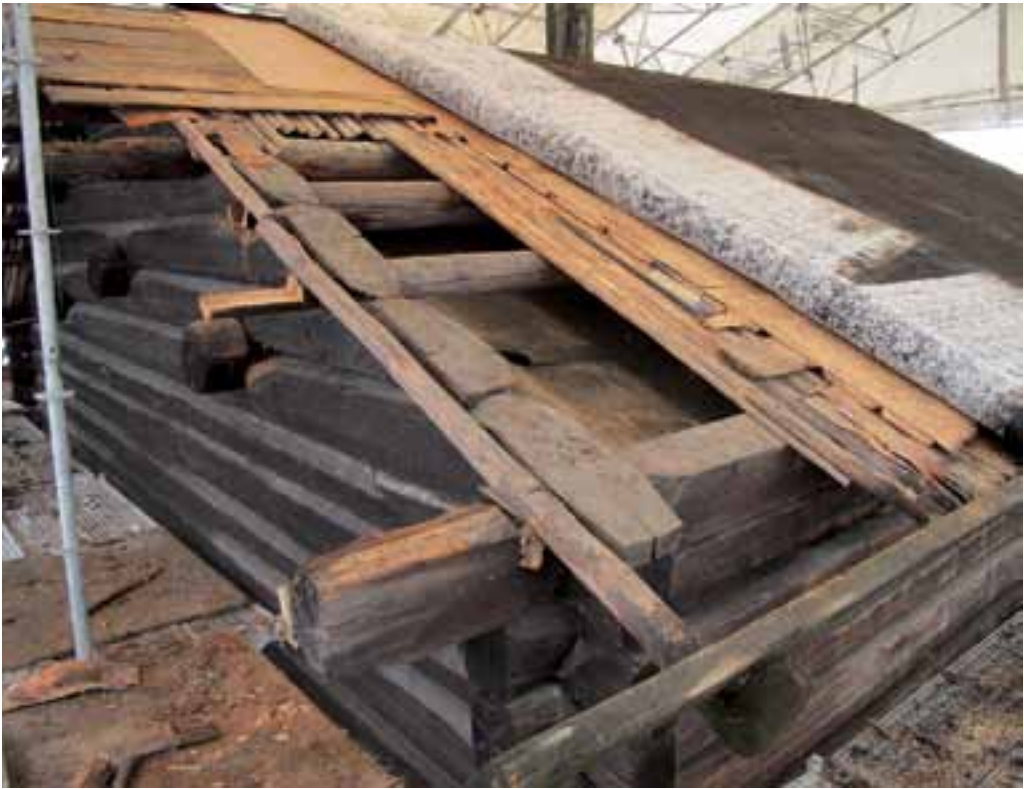
2. Roof layers under restoration.

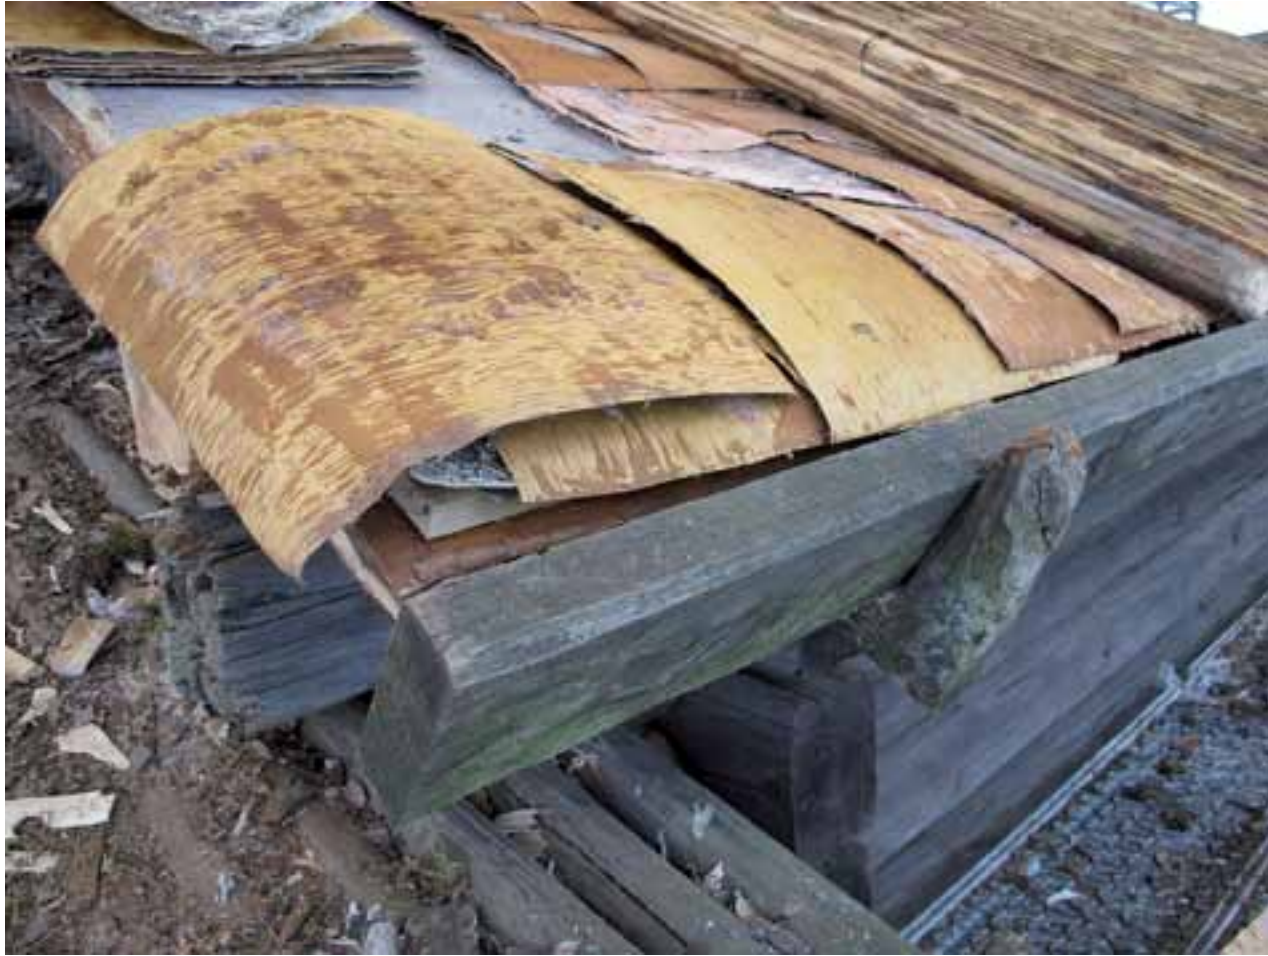
3. Laying the birch bark.
